# Manhole Inspection Summary

Manhole # S43K\_\_009MH

Insp Date: **12/18/08 10:24 AM**

**Location** Address: **601 s caroline st**

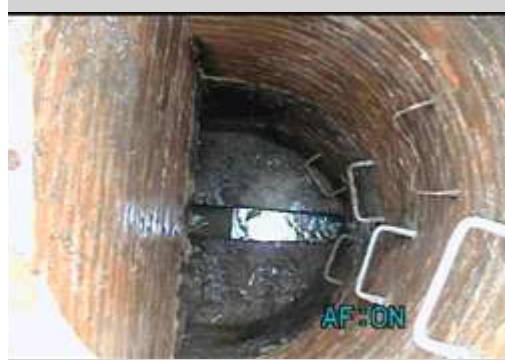
Top View

Pipe out is under shelf

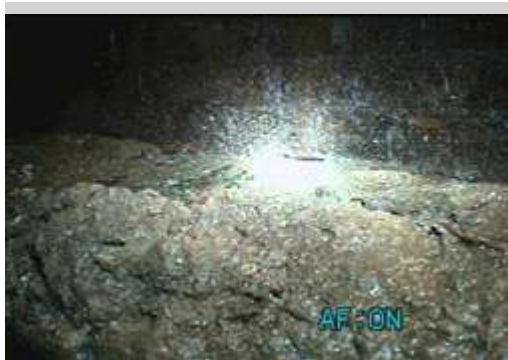
Defect 3

Condition: ☒ Sound ☐ Cracked ☐ Root Intrusion ☐ Deteriorated ☐ Leaks ☐ Debris

bench debris

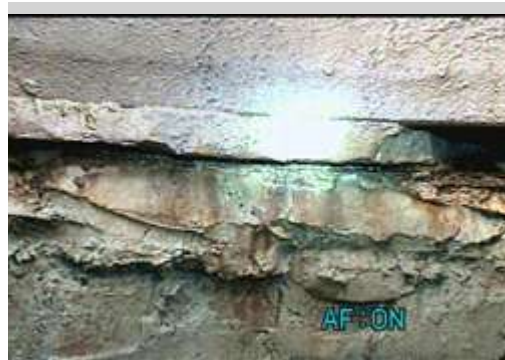
Defect 2

Condition: ☐ Sound ☐ Cracked ☐ Root Intrusion ☐ Loose Brick ☒ **Deteriorated**

Infiltration: ☐ None ☒ **Joint** ☐ Cracks ☐ Mortar ☐ Roots ☐ Wall

chimney deteriorated at frame joint

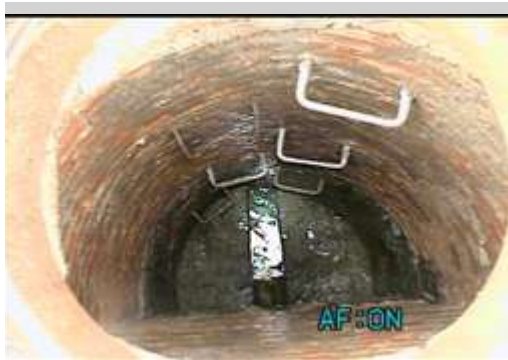
Defect 1

Condition: ☐ Sound ☐ Cracked ☐ Root Intrusion ☐ Deteriorated ☐ Leaks ☒ **Debris**

Count: **6** Missing: **0** ☒ **Corroded**

channel debris, steps corroded

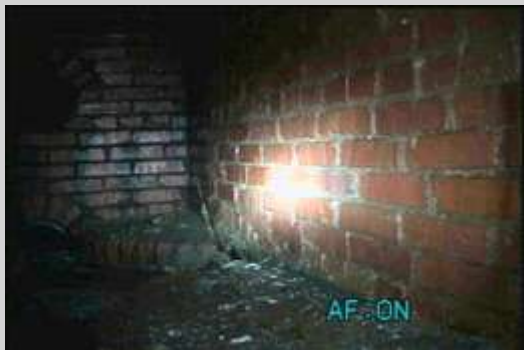
12 O'Clock Outflow

on right side of photo. cant get to the pipe,  
too far away under shelf

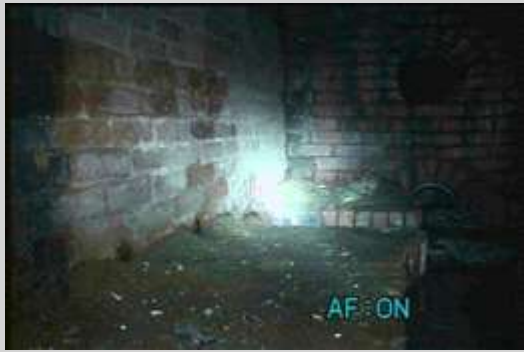
6 O'Clock Inflow

on left side of photo. Too far under shelf to get good pic
